WAR DEPARTMENT  
U. S. ARMY AIR FORCES  
REPORT OF AIRCRAFT ACCIDENT

(1) Place: San Giovanni Air Base, Italy. (2) Date: 12 May 1945 (3) Time: 1030H  
 AIRCRAFT: (4) Type and model: B-24H (5) A. F. No.: 41-28798 (6) Station: APG 520  
 Organization: (7) 15th Air Force (8) 454th Bomb Gp (9) 738th Bomb Squadron (H)  
(Command and Air Force) (Group) (Squadron)

UNSATISFACTORY REPORT

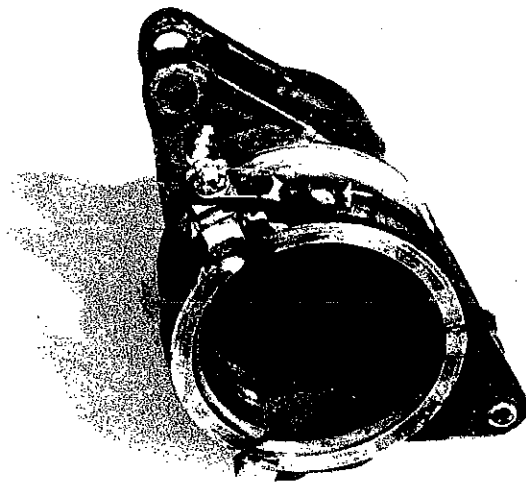
UR # FS 45-989 COLLAR, SIDE BEARING TO  
PWT # 326024L B-24-M 41-28796

- Facts:**
  - Investigation disclosed that the side brace retracting collar had apparently failed, either prior to or while landing. This was an old style side brace retracting collar with only three (3) actuating lugs.

- Accompanying photographs show the apparent faulty welding of the arm to which the latch release link assembly is fastened. Also shown in photographs is the failure or shearing of lugs on side brace retracting collar.

- Thorough check of actuating cylinders on both gears revealed no leakage, and locking mechanism on left side brace was serviceable.
- Probable causes:** It is believed that the above mentioned failures, either individually or combined, while landing, caused the failure of left main landing gear.

- Recommendations:** That an immediate and thorough investigation of the accompanying side brace retracting collar be made to insure against like failures on the same series and model airplanes.
