WAR DEPARTMENT  
U. S. ARMY AIR FORCES  
REPORT OF AIRCRAFT ACCIDENT

(1) Place: San Giovanni Air Base, Italy. (2) Date: 12 May 1945 (3) Time: 1030H  
 AIRCRAFT: (4) Type and model: B-24H (5) A. F. No.: 41-28798 (6) Station: APG 520  
 Organization: (7) 15th Air Force (8) 454th Bomb Gp (9) 738th Bomb Squadron (H)  
(Command and Air Force) (Group) (Squadron)

UNSATISFACTORY REPORT

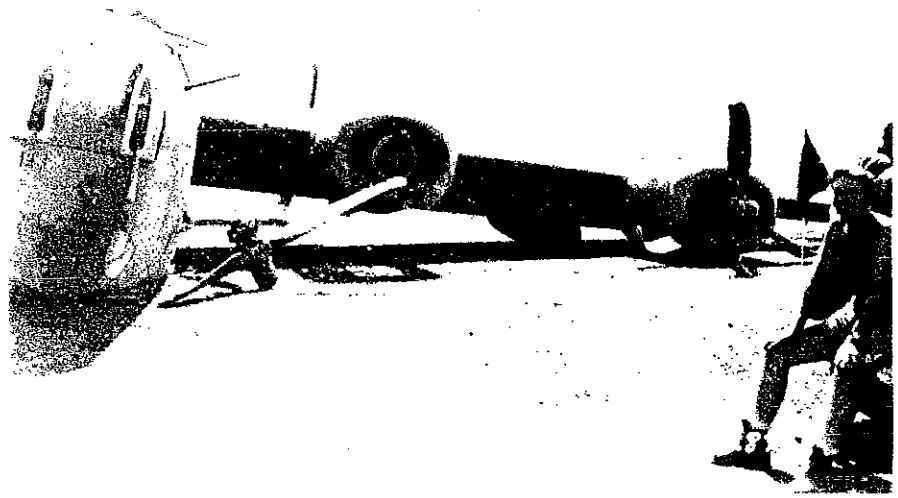
(57) Cause of accident: Side brace retracting collar lugs sheared preventing left main landing gear from latching.

- Facts:**
  - Investigation disclosed that the side brace retracting collar had apparently failed, either prior to or while landing. This was an old style side brace retracting collar with only three (3) actuating lugs.

- Accompanying photographs show the apparent faulty welding of the arm to which the latch release link assembly is fastened. Also shown in photographs is the failure or shearing of lugs on side brace retracting collar.

- Recommendations:** That an immediate and thorough investigation of the accompanying side brace retracting collar be made to insure against like failures on the same series and model airplanes.
